### **Fountain Valley**

## **Brinks Services Utilizes Two Repair Processes -- MaxLiner and Formadrain -- at Industrial Park**

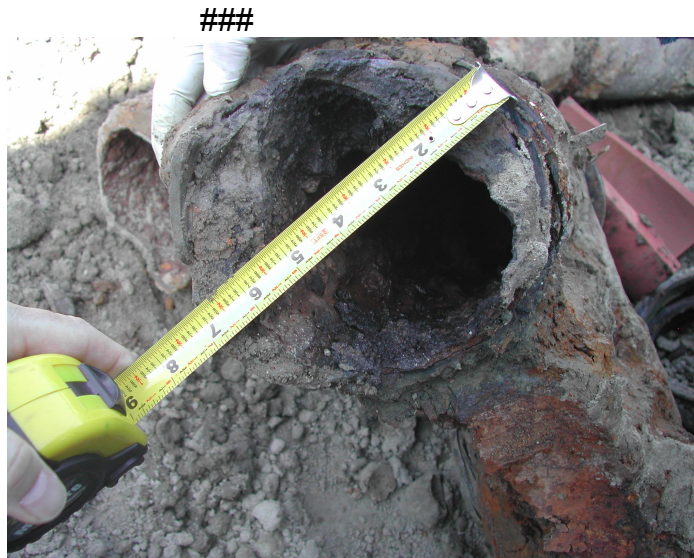
After examining the condition of the pipes with a sewer camera with a real-time video link, Bill Brink, owner of Brinks Services, chose to attack the problem by utilizing two different products: **MaxLiner** for the heavily corroded, 6" pipe in the lower portion nearer the front of the complex, and **Formadrain** for the longer upper portion where the camera revealed long sections of the original 4" drain pipe had actually deteriorated. Corrosion in the 6" pipe had narrowed the passage to less than 4".

Another factor in the choice of product was that the degree of slope changed at the same junction point. Code called for two degrees of slope, but the lower portion was only one degree. This condition caused greater buildup of corrosive matter in the lower section. With less slope, more solids and chemicals settle and deterioration accelerates.

This 6" inch pipe had heavy build up where an 1-1/2" + of pipe diameter was lost on each side

In preparation, the Brinks crew reamed out the entire sewer line with lengths of plumber's snake followed by a high-pressure water jetter. Opening up the narrowed passage, however, required more: a customized tool was needed.

projects,” Brink said. “Custom work on this job was needed. We created an abrasive high-speed (22,000 RPM) rotary cleaning tool. It is similar to what you need when you want to hone a cylinder on engine block prior to putting in a new piston. The technique was much more effective than sewer snakes and hydro-jetting used by competitors as it cleaned the pipe down to the original bare metal”
