Galvanized and Copper Pipes in Historic Lake Arrowhead Boat House Preserved with CuraFlo Epoxy Pipe Lining

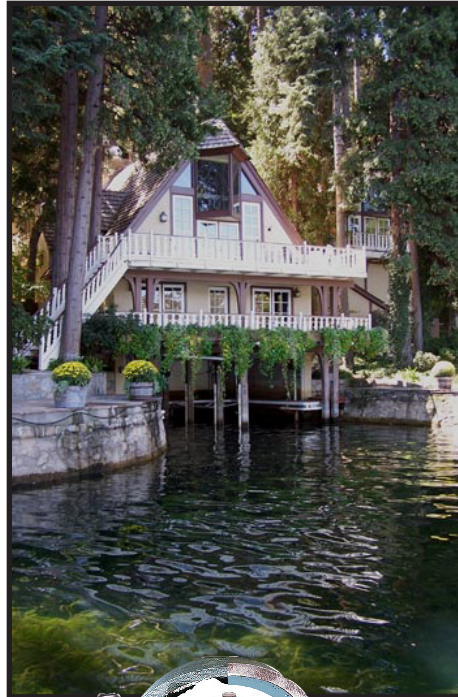
Brinks CuraFlo of San Diego came in with an affordable proposal to line the aged pipes with their proprietary, high-tech, epoxy formula. The patented process includes drying and cleaning the inside of the pipes, and then blowing the epoxy lining into the piping system in 100-foot segments, filling pinhole leaks and creating "a pipe within a pipe."

Brinks' four-man, three-vehicle crew was in and out of the historic Boat House in four weeks, on time and on budget. Their restoration bid was a fraction of the repiping cost.

Much of the plumbing system had to be brought up to current building codes, including forming a "dielectric union" between the galvanized and copper pipes wherever they were joined to inhibit electrolysis. Brinks' crew used electric current and fiber optic technology to trace and locate every joint and turn of the pipes in the walls, under stone floors and under ground. The hot and cold lines were cleaned and coated separately, leaving a source of water in service most of the time.
