# Pipe Systems at Tri-City Medical Park Restored with Brinks CuraFlo Epoxy

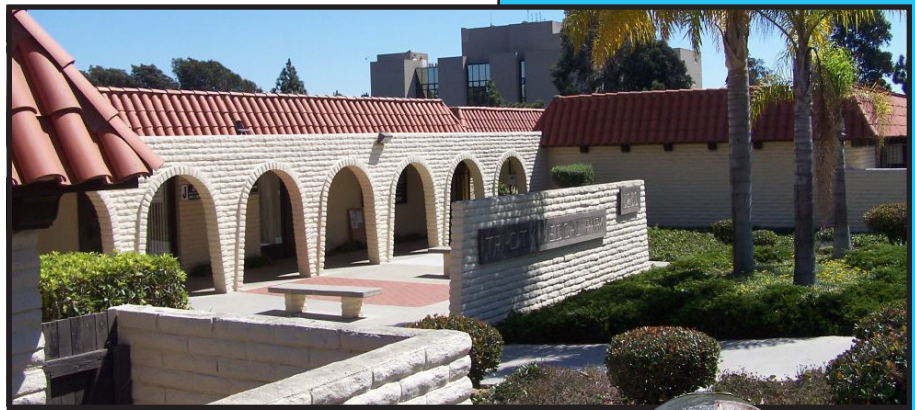
As the CuraFlo work crew tackled each suite or section of the Tri-City piping system, they drained and then dried the isolated portion by sending heated, dry, oil and moisture free compressed air through

the pipe. Then the pipes were cleaned to a “white metal finish” condition by shooting silica corundum down the line that blasts away corrosion and encrustation.

Finally, the inside of the pipes were coated with Curapoxy epoxy coating material at an average thickness of 16 mils. The Curapoxy system equipment is capable of shooting the epoxy to a distance of 100 feet. Thickness can be adjusted from 7 to 1000 mils.
